# The Human Factors Relating to Escape and Survival from Helicopters Ditching in Water

AGARDograph No. 305 (E)

**Captain (N) C. J. Brooks**

*Defence & Civil Institute of Environmental Medicine, Downsview, Ontario, Canada — Advisory Group for Aerospace Research and Development (AGARD), NATO*

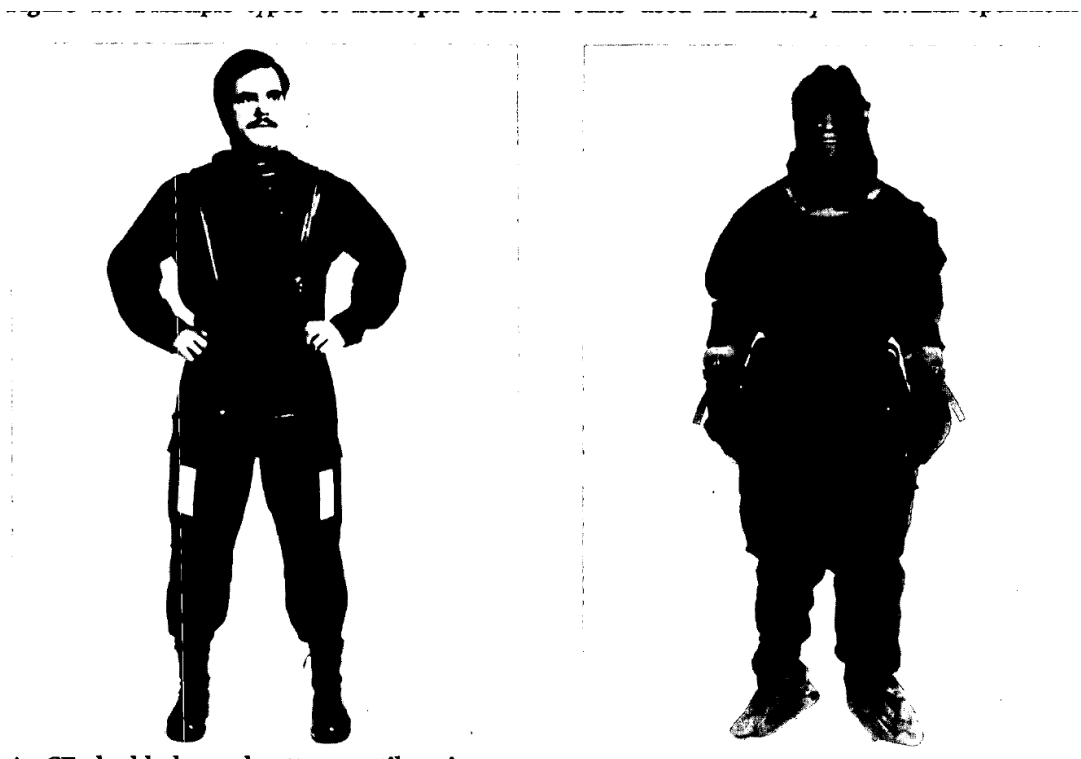
A. CF double layered cotton ventile suit, B. CF Quick-don suit, - Semi-vertical zip. - Horseshoe zip. (Courtesy Mustang Industries Inc.)

C. RAF upper half single layered cotton D. USN Cortex Nomex suit. - Transverse zip. ventile suit for NBC conditions. (Courtesy N.A.D.C. Wanninistet Pa.) - Diagonal zip. (Courtesy Dunlop - Beaufort Ltd.)

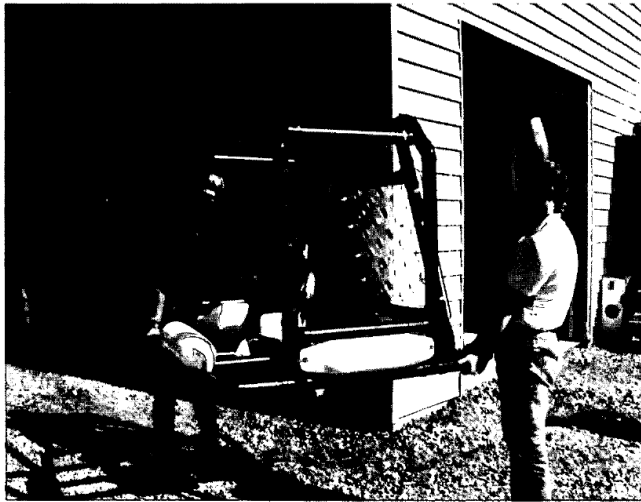
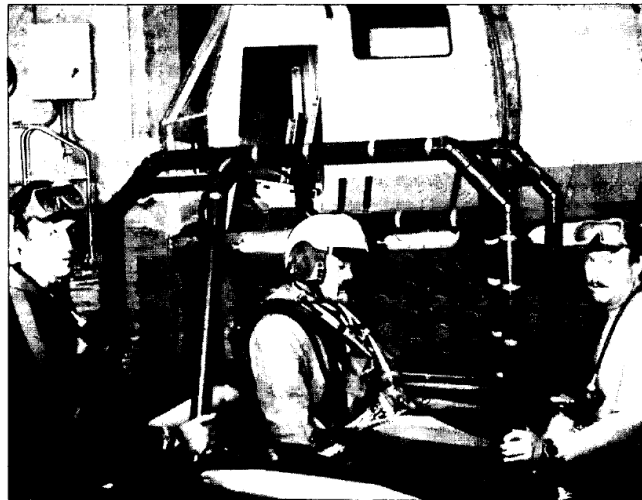
Figure 19. The Brooklyn Shallow Water Escape Trainer (SWET). (Courtesy U.S. Coastguard and Survival Systems Ltd. Dartmouth, N.S.)

As has previously been mentioned, there has been much discussion concerning the safety of training personnel with an underwater breathing apparatus, particularly the possibilities of air embolism and ruptured lung. Recently the US Coastguard has put into service a simple, portable, inexpensive device, constructed from plastic plumbing pipe, called the Brooklyn Shallow Water Escape Trainer (SWET). It resembles a cube with no solid sides, the plastic pipes form the external margins (Figure 19). There are two additional bars fitted to enable the instructor to rotate the device to the inverted position. In the centre of the open cube a seat and harness is fitted; ahead of this, if required, a mounting can be placed for an emergency breathing device (if the device to be used is not man-mounted). In the open areas on either side of the seat outlined by the plastic pipe, it is possible to fit windows, hatches and release mechanisms that represent the type of helicopter used by the student. In order to prevent the student suffering from an air embolism or ruptured lung, buoyancy bags are fixed to the underside of the SWET. This ensures that the students' head to mid-thorax distance is never more than 105 Centimetres (3 feet) underwater. As a further precaution, training in the SWET is limited to a pool depth of 1.5 metres (5 feet).

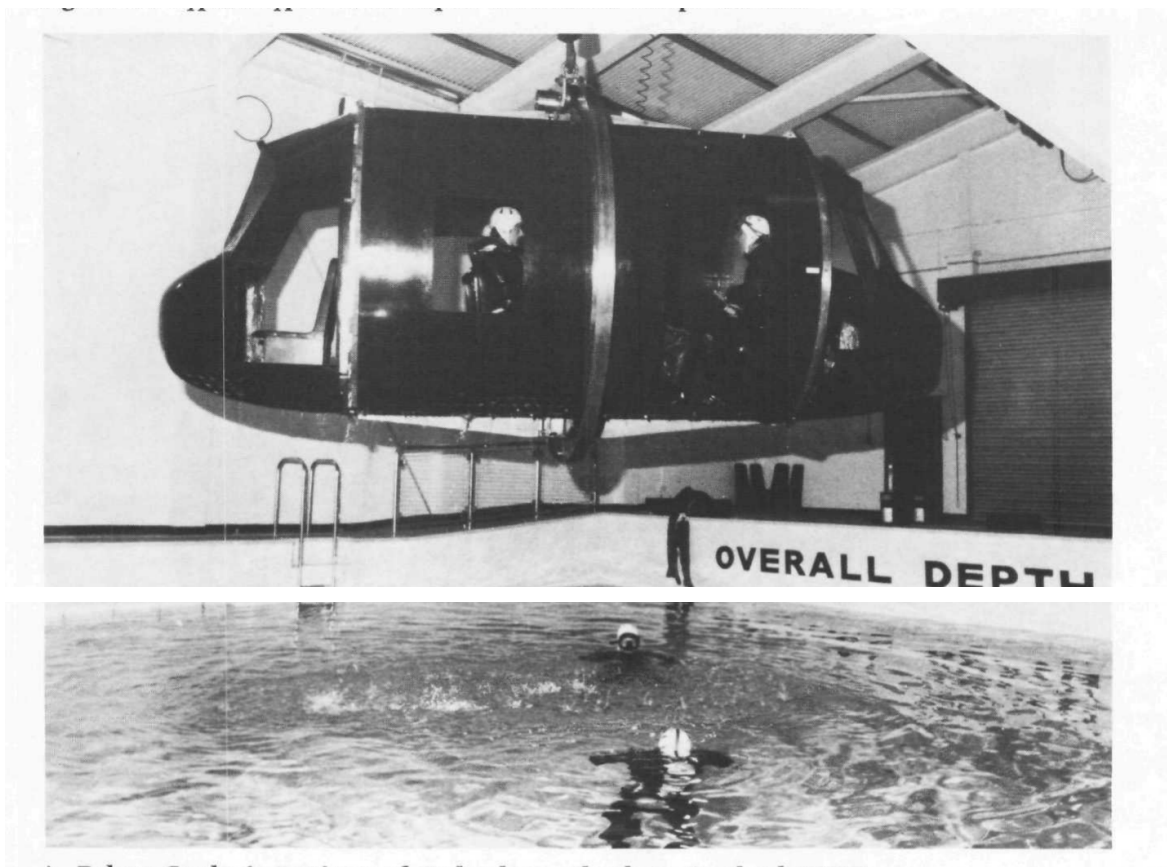
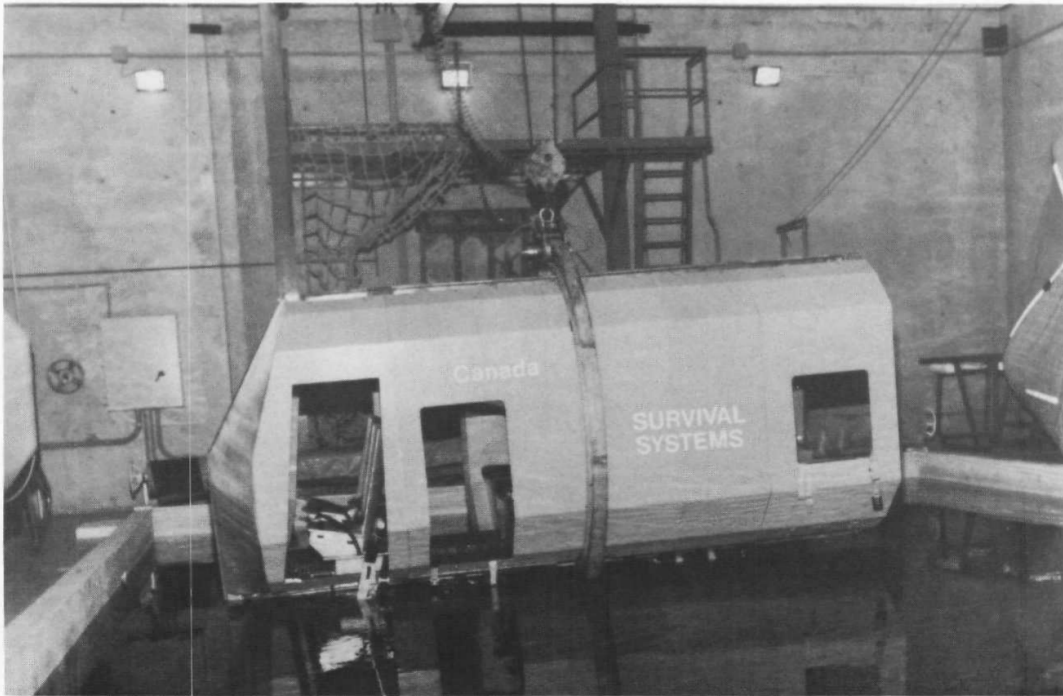
A. Robert Gordon's Institute of Technology, Aberdeen, Scotland HUET.

B. Survival Systems, Dartmouth, Nova Scotia. Modified HUET.

C. U.S. Navy Burtech 9D5 N.A.S. Pensacola, Florida.

D. Royal Navy, H.M.S. Heron, Yeovilton, Modified HUET.
